## **Evaluating the Pedestrian Environment in Abu Dhabi**

This paper evaluates the pedestrian environment in Abu Dhabi. The evaluation, conducted in conjunction with the Abu Dhabi Master Transportation Plan, focuses on two parts. The first addresses the overall adequacy of the walkway environment. The second deals with the various pedestrian crossing facilities used in the city. The walkway environment is generally adequate, but locations exist in which walking is difficult, dangerous, or not feasible. Several urban design aspects that enhance the walking environment are discussed. The performance of uncontrolled, controlled, and grade-separated mid-block pedestrian crossings, is evaluated, as well as pedestrian crossings at roundabouts and signalized intersections. Both marked and unmarked pedestrian crossings function effectively as unmarked crossings, due to the lack of regulations forcing drivers to yield to pedestrians in marked crossings. Their performance is enhanced by the presence of medians, which are not always well maintained. At signalized intersections, pedestrians can find generally adequate crossing opportunities, but pedestrian green time is too short at some loca

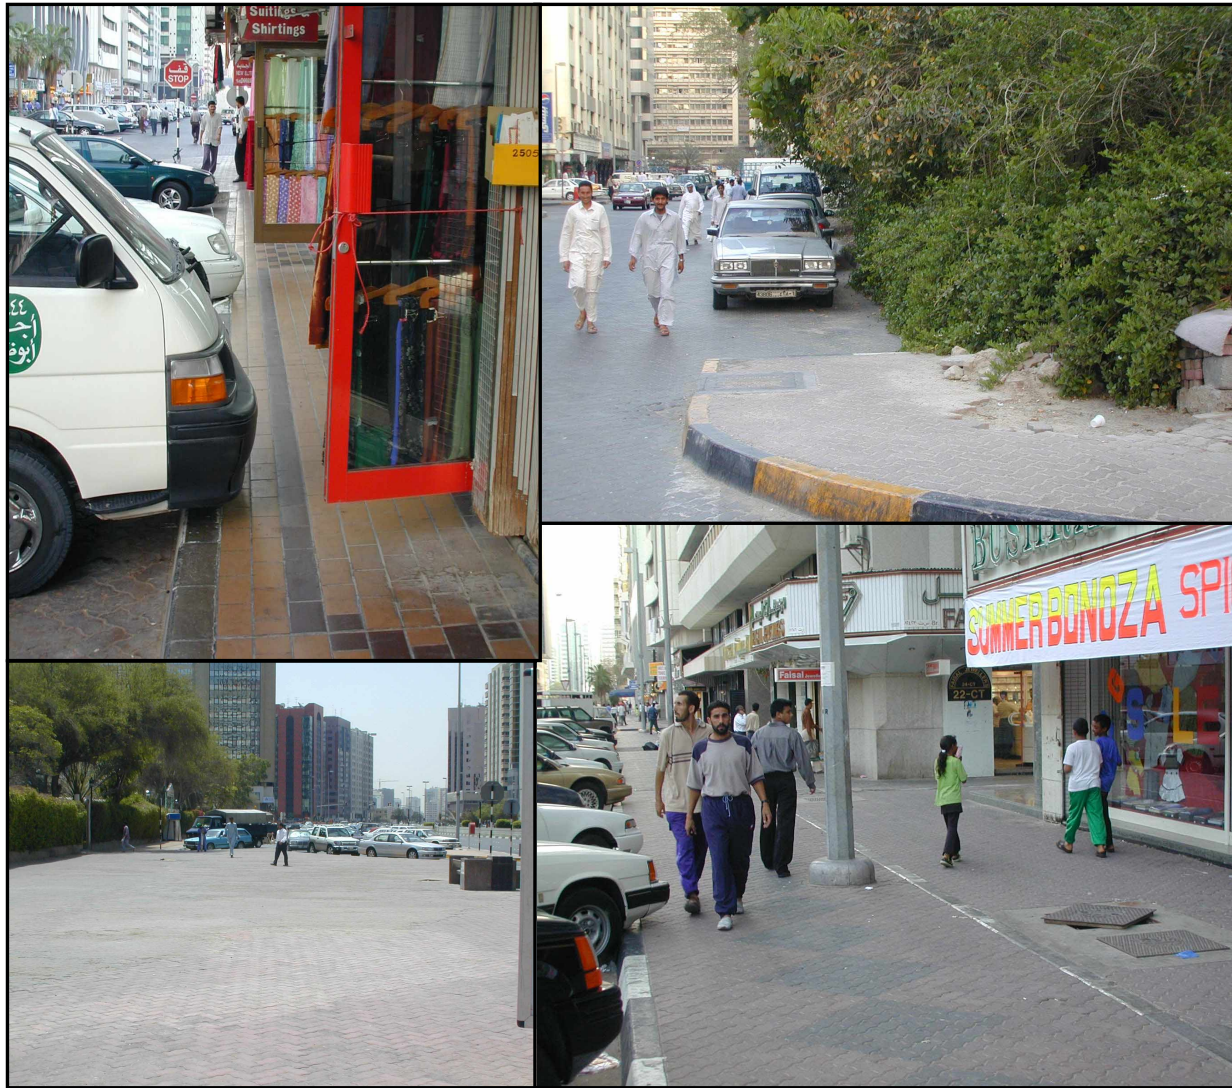
**FIGURE 1** Examples of sector pedestrian facilities

Downtown Abu Dhabi is characterized by mixed land uses. Within sectors, sidewalks along buildings generally exhibit good overall continuity and width appears adequate (See Exhibit 1). Even along strips of shops and other commercial activities, sufficient width often remains even when various types of street furniture and other obstructions exist.

However, there are situations when a narrow sidewalk, sometimes less than 1.2 meters in width, parked cars, obstructions protruding from shops, and street furniture make walking inconvenient or infeasible. Some shop owners permanently use sidewalk space. These situations may pose difficulty for some pedestrians, including the elderly, people with baby strollers, or young children, especially residents who have no choice in regard to their immediately adjacent walking environment. In addition, vertical clearance is inadequate in some locations, due to low-mounted air-conditioners. This poses a clear risk of injury. In rare cases, a sidewalk is completely missing.

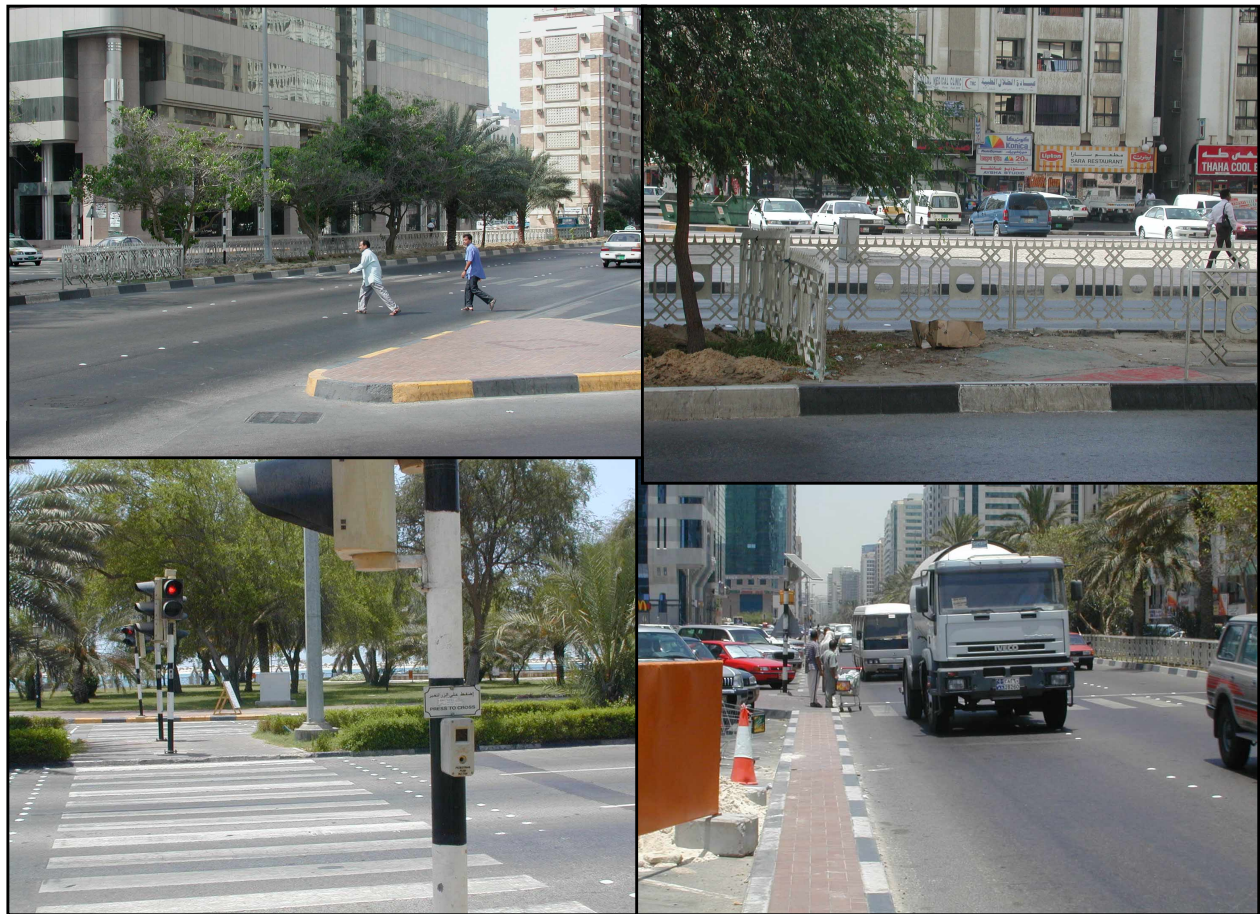
**FIGURE 2** Examples of mid-block pedestrian crossings

The distances between junctions are too long to prohibit crossing the street at-grade, between the signalized intersections. In addition, certain land use distributions (e.g. a parking garage located across the street from a shopping mall) encourage mid-block crossings. In the following sections, detailed evaluations of mid-block crossings (see Exhibit 2) are provided.

Wrought-iron fences are often used to regulate mid-block median crossings by pedestrians in the CBD. Many openings in the fences are provided, creating opportunities for pedestrian crossings. Spacing varies, and is usually in the order of 100-200 meters. In addition, many other informal openings can be found throughout over the city, in locations where no fence exists, and places where the fence was simply broken down by pedestrians.

The Municipality has formalized some of these crossings, both in locations with fences as well as those without, by paving safety islands in the median openings and providing pedestrian pavement markings (zebra striping) and signs warning motorists of the presence of pedestrian crossings.

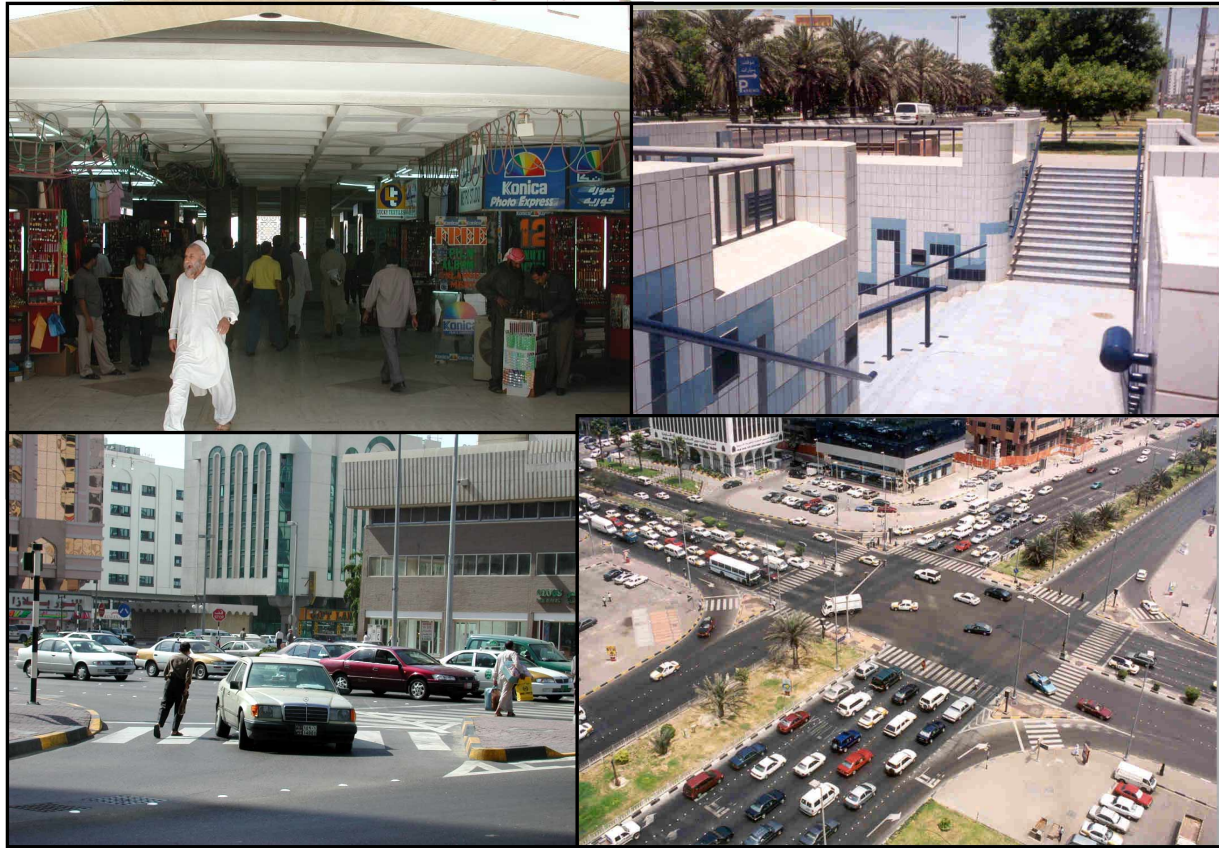
**FIGURE 3** Examples of grade-separated and signalized pedestrian crossings

There is one controlled mid-block crossing in Abu Dhabi. This is a push-button actuated mid-block pedestrian signal, located on Corniche Road. The pedestrian cycle is designed such that there is a minimum of 55 seconds between the end of one walk phase and the beginning of the next. The minimum time it takes to turn green is 15 seconds. Pedestrians often get impatient and cross after pressing the button, but before the pedestrian signal turns green.

The Grade-Separated Pedestrian Crossing program forms an important element of the city's transportation infrastructure. Currently, there are eight underpasses and one overpass (See Exhibit 3). The Grade-Separated Pedestrian Crossing program is proceeding with the design and construction of an additional 22 underpasses already approved by the government, primarily in the downtown area. Other underpasses are planned.

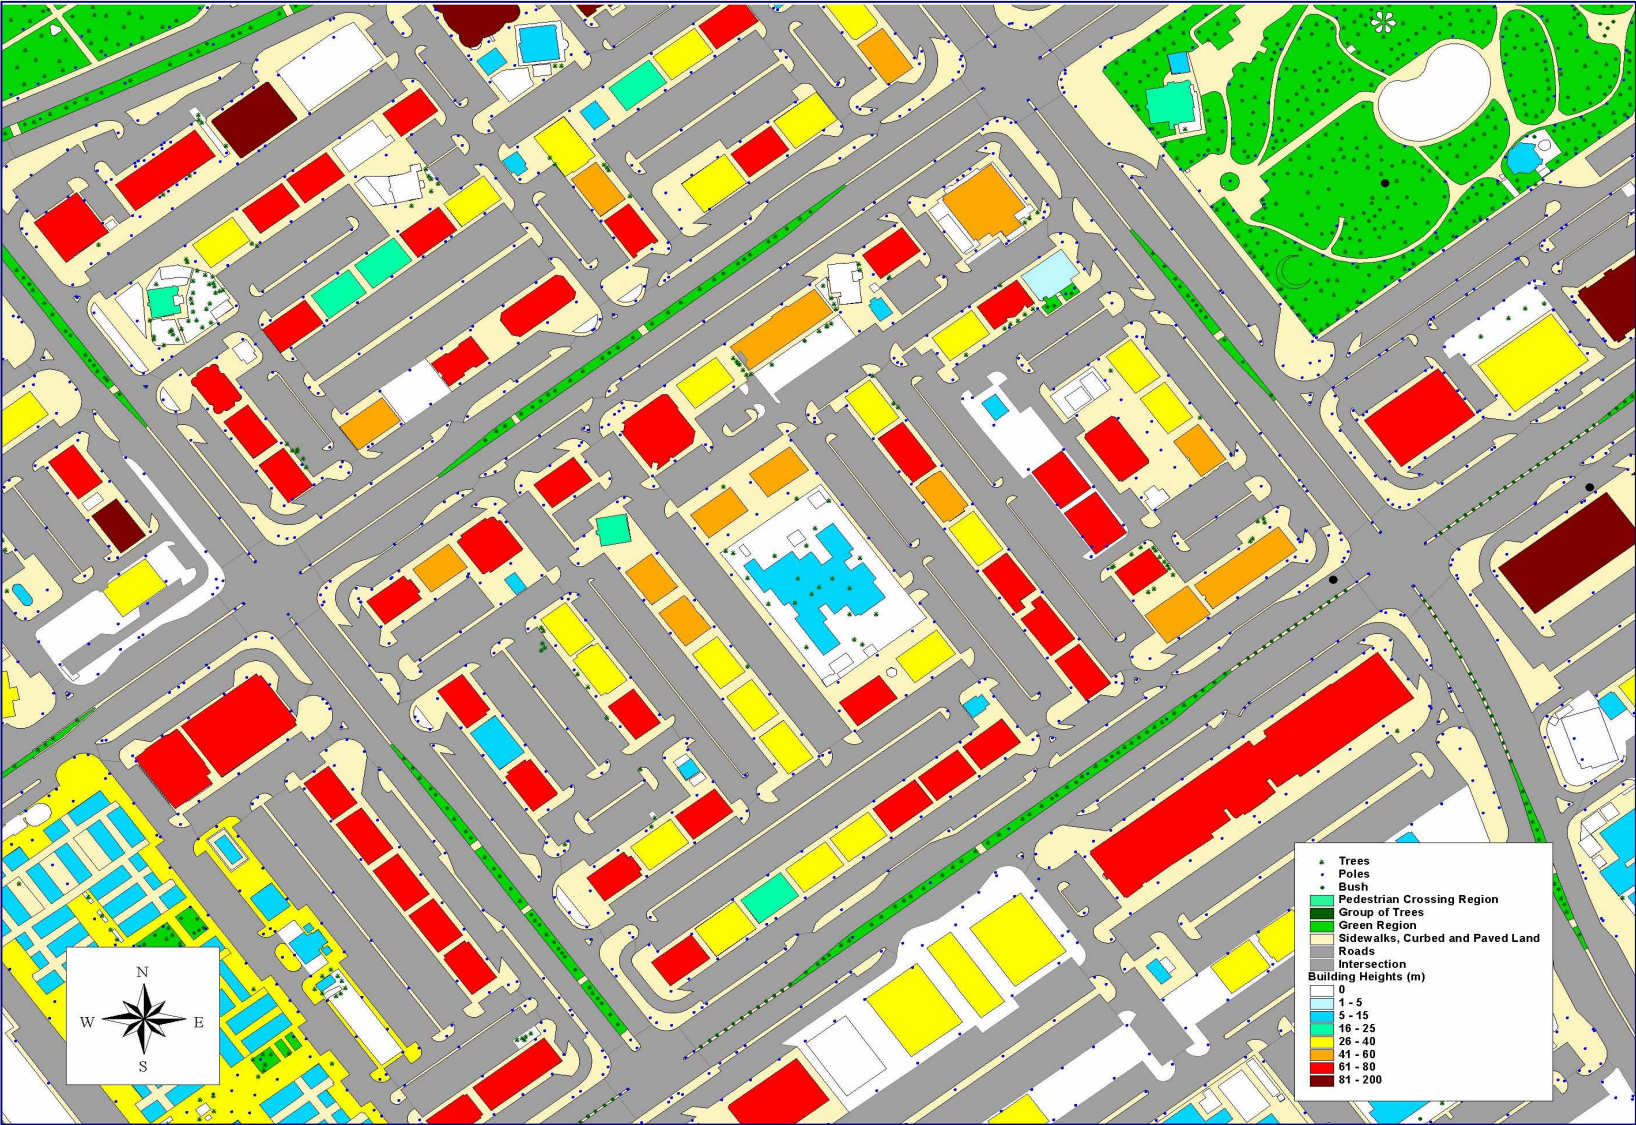
FIGURE 4 GIS Plot of downtown Sector

16. A more rational, quantitative method should be developed to combine accident and design aspects into a summary index for various neighborhoods to allow a systematic assessment. The Abu Dhabi Municipality's GIS can be used for this purpose (See Exhibit 4). The GIS is quite detailed, and includes street furniture such as light poles, as well trees and green areas, in addition to all paved and curbed land. The updated GIS allows for a more systematic analysis of the pedestrian environment. The width and area of walkways and sidewalks can be measured effectively, street furniture such as telephone booths or benches not currently included can be added, and

comparisons between the year 1995 and year 2000 can be made in regard to various features. For example, the area of paved and curbed land can be compared to assess whether urban space devoted to pedestrian uses has declined, and by how much. Use of the GIS will also facilitate preparation of a detailed pedestrian improvement plan for individual areas or sectors.
