# **Rideau Canal Corridor Pedestrian Crossing Study**

**Queen Elizabeth Dr.: Preston St. to Laurier Ave.  
&  
Colonel By Drive: Hog's Back to Daly Ave.**

# **RIDEAU CANAL CORRIDOR - PEDESTRIAN CROSSING STUDY:** **QUEEN ELIZABETH DRIVE AND COLONEL BY DRIVE** Evaluation Site Locations

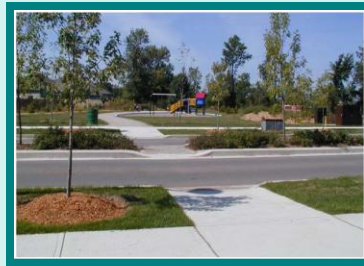
- **Refuge Islands:**

A number of opportunities to provide this option.  
(Not a crosswalk.)

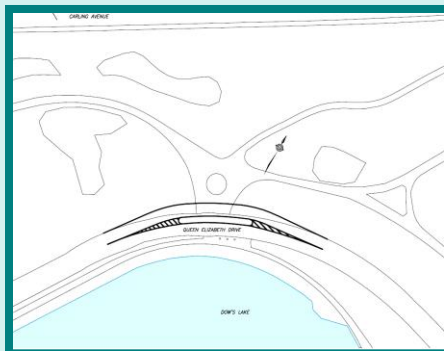
## OPTIONS:

1. Widen road to provide refuge median at locations 1 & 2
2. Construct wider median the full distance between locations 1 and 2

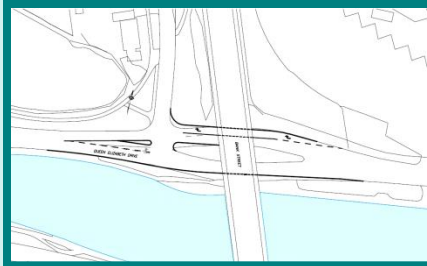
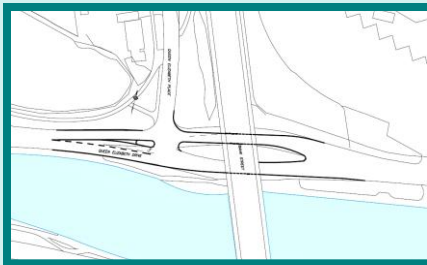
## OPTIONS:

1. Maintain (minor road) stop control intersection with geometric changes.
2. Same as Option 1 except eliminate WB right turn lane.
3. Construct a single lane roundabout.
4. Do Nothing

The following options warrant consideration:

- Convert intersection to a Roundabout
- Maintain minor road stop control with new splitter island on south side and elimination of southbound right turn lane.
